Welcome and thank you for choosing CNY Preferred Home Inspections.

Report Summary

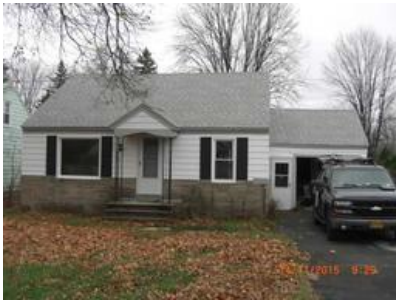
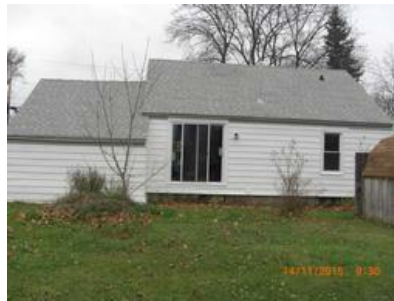
There are no gutters on the house. Gutter systems are necessary in order to help reduce water and moisture damage to our homes. The wetter the climate the more we need a properly functioning gutter system. Water that collects next to the foundation of a house will tend to find its way into some part of the structure and that can cause water and moisture damage. Recommend contacting a licensed contractor to repair as needed. (see Basement section)

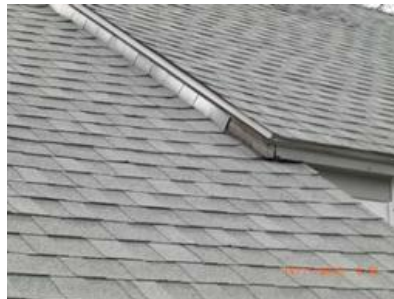
11/15/2015 Noted some sagging in the decking. (see Attic section)

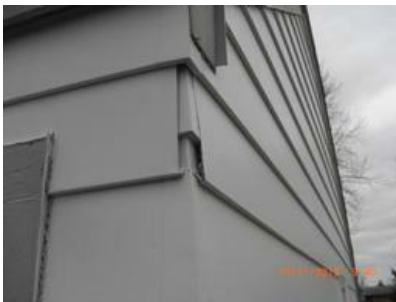
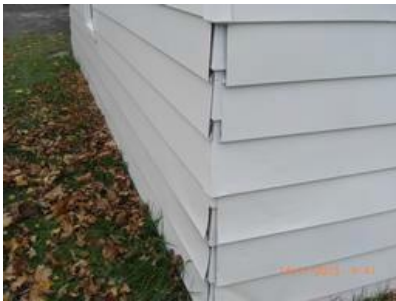
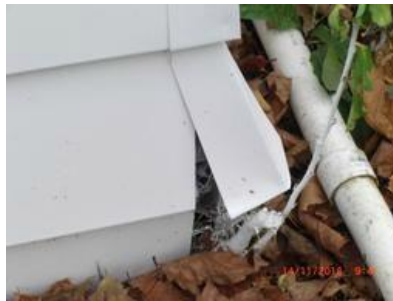
11/15/2015 Noted missing siding and gaps on outside corners (garage). Cosmetic damage noted throughout and the siding has come loose around the A/C unit disconnect. Recommend contacting a siding contractor for repairs as needed.

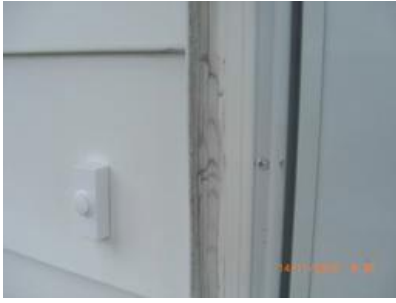
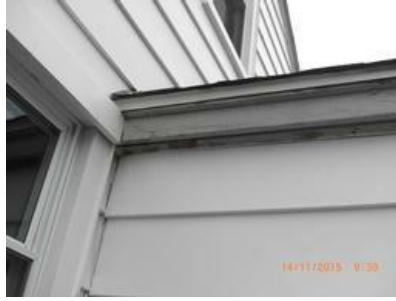
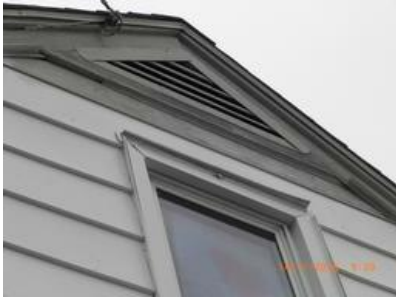
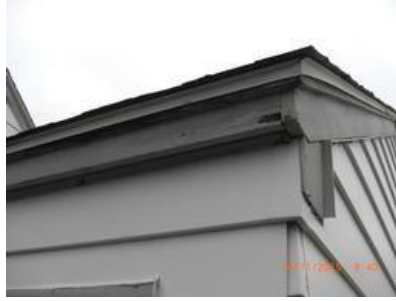
11/15/2015 There are areas of trim where the bare wood is exposed to the elements. Contact a painting contractor for repairs as needed.

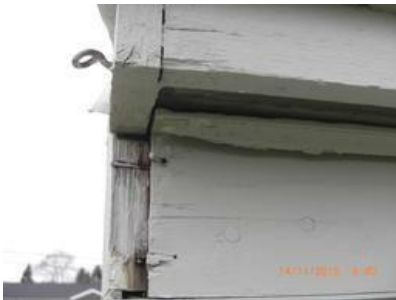
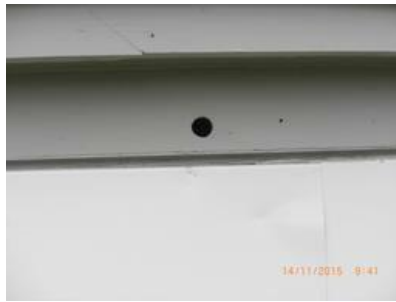
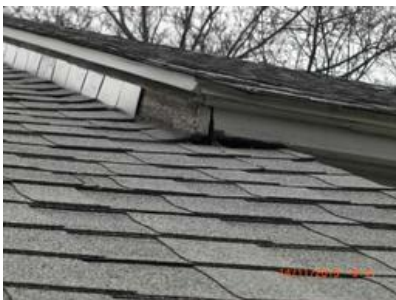
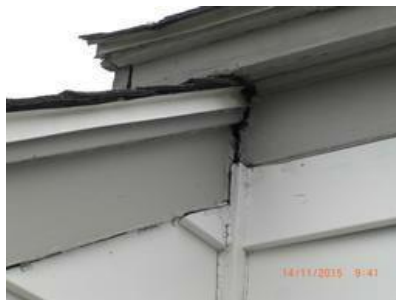
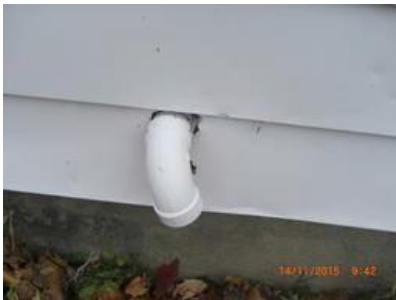
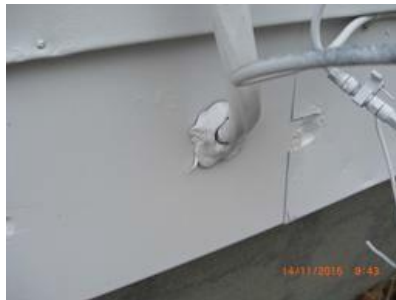
Caulking is missing or in poor condition in a variety of areas allowing for water penetration. Notably, multiple wall penetrations should be filled/caulked to prevent water infiltration and/or infestation. Recommend contacting a general contractor for repairs as needed.

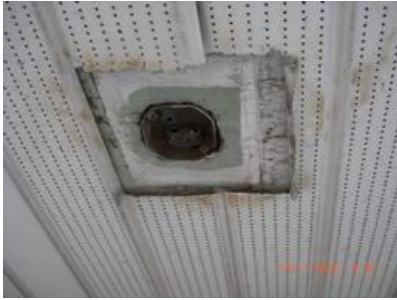
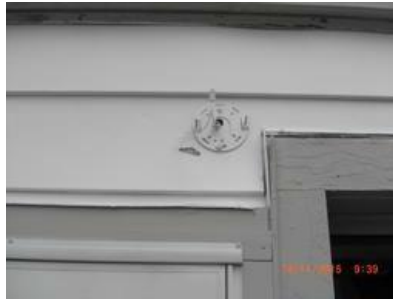
There were missing light fixtures. These should be installed or capped accordingly to prevent safety issues. Recommend contacting an electrician for repairs as needed.

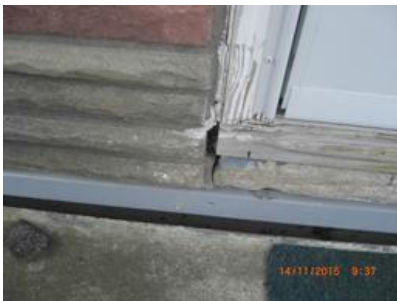
There has been some movement between the house and front porch slab. This is not uncommon for a house this age. Monitor this area for further movement possibly becoming a safety hazard. Contact a mason for repairs as needed.

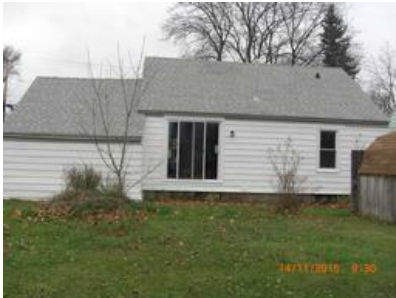
There is a sliding glass door installed in the rear of the house with no landing. Recommend contacting a general contractor/mason for remedy.

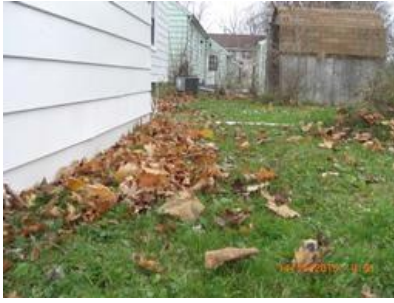
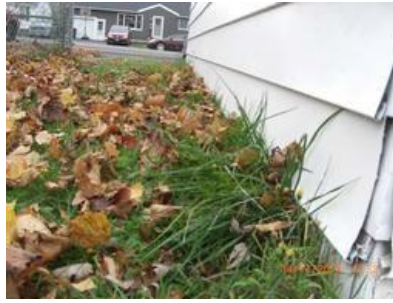
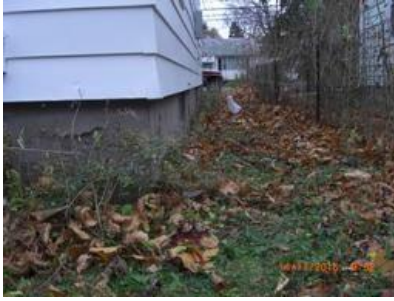
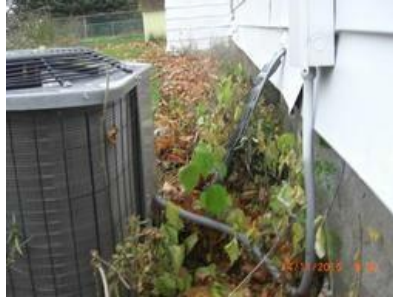
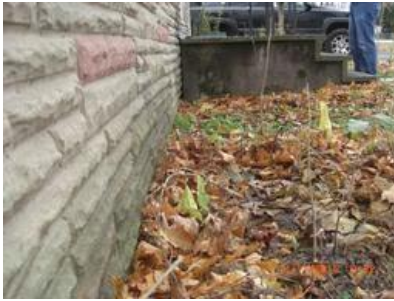
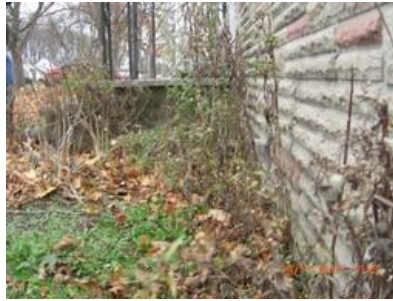
Perimeter grading slopes towards the home. Recommend grading soil so it slopes down and away from the building to direct rainwater away from foundation. Contact a Landscaper as needed for repairs.

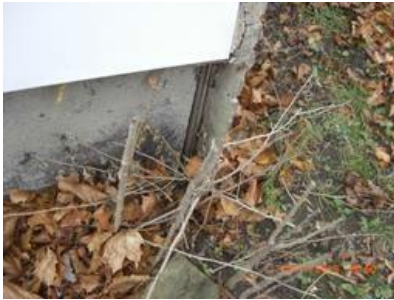
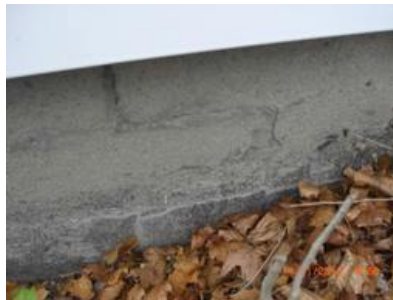
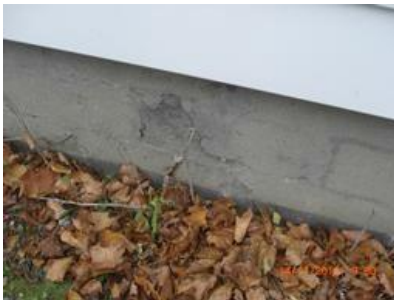
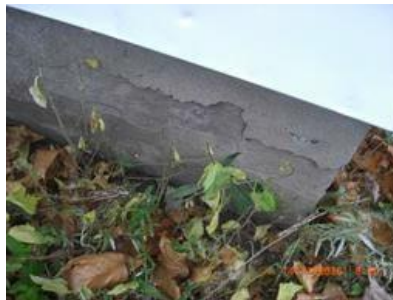
11/15/2015 Small cracks and missing parge coat were noted on the foundation. This can allow water infiltration, and if not remedied, over time can cause foundation issues. Recommend contacting a mason for repairs as needed.

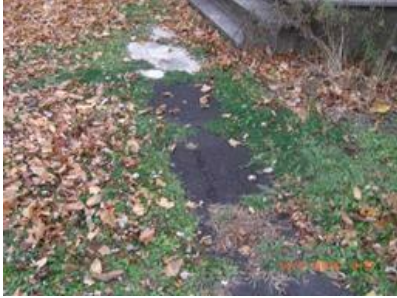
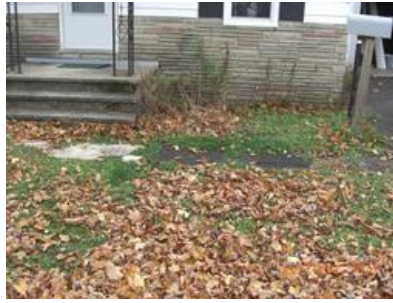
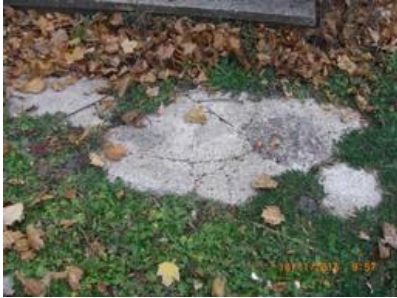
The main walkway to the front porch is covered with overgrowth and shows signs of deterioration. This is a trip hazard. Recommend contacting a mason for repairs as needed.

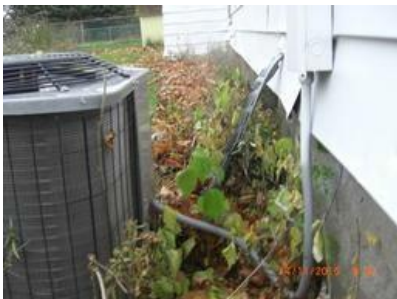
There is vegetation in contact with siding/foundation. Recommend pruning or removing vegetation so there's at least a one foot gap between vegetation and siding. This will help prevent water from pooling against the foundation.

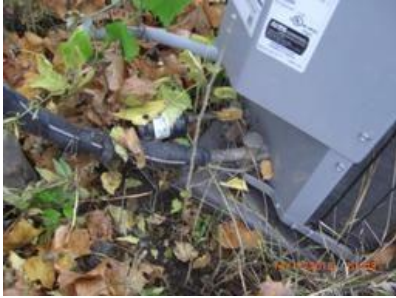
11/15/2015 Insulation did not extend the full length of the coolant line. Recommend contacting and HVAC contractor for repairs as needed.

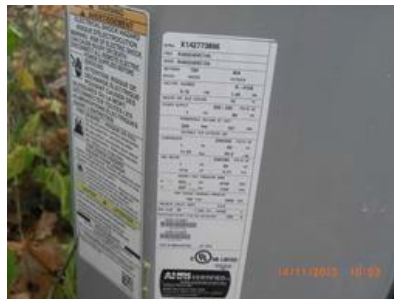
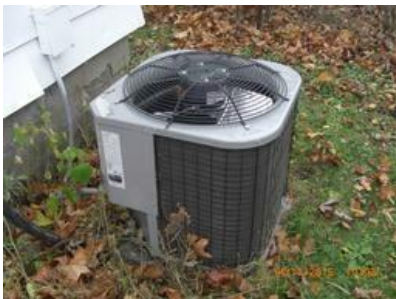
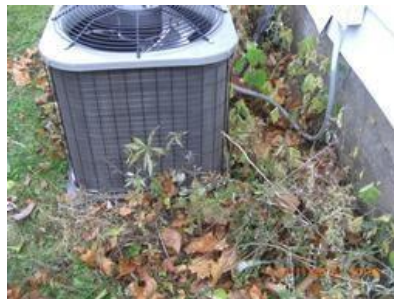
11/15/2015 Recommend removing debris from around the unit. It appears that some vegetation has grown inside the grill of the unit and should be removed.

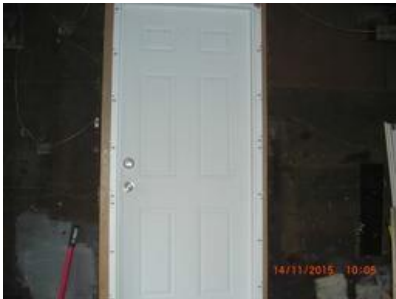
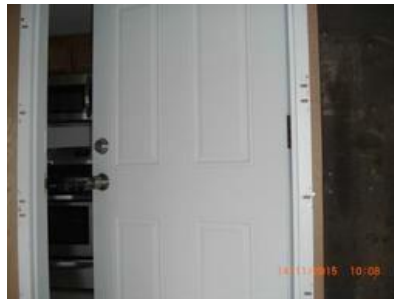
11/15/2015 The service door between an attached garage and a house should be self-closing as a protection against fire and carbon monoxide. Recommend contacting a general contractor for repairs as needed.

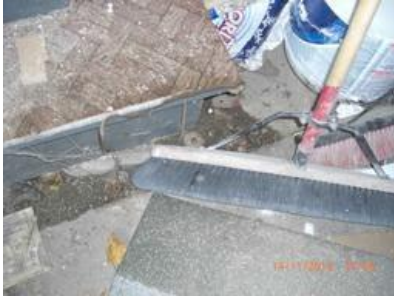
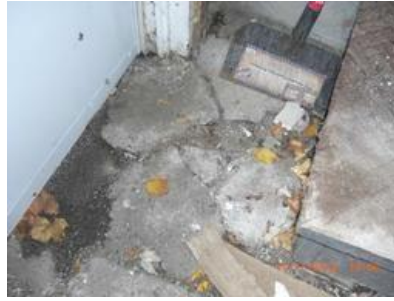
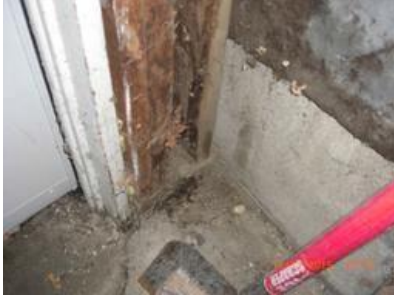
11/15/2015 Noted deteriorated concrete at the entry from the exterior door. This is a trip hazard. Recommend contacting a mason for repairs as needed.

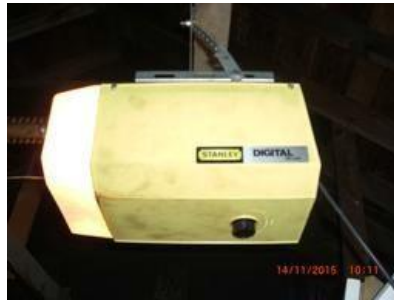
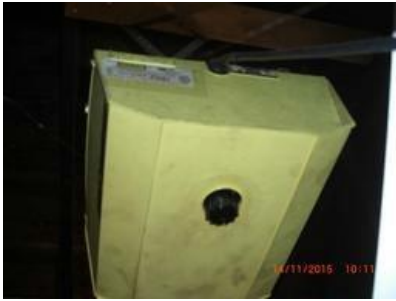
Missing Photo Electric Eyes

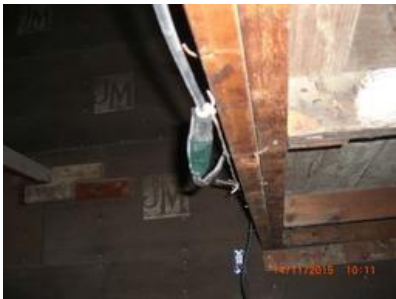
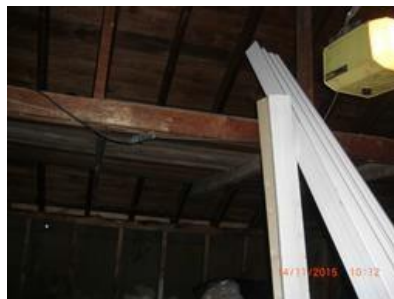
Extension cords are being used as permanent wiring for the garage door opener. They should only be used for portable equipment on a temporary basis. Using extension cords as permanent wiring poses a fire and shock hazard, and is an indication that wiring is not adequate and should be updated. Recommend either removing extension cords or having a qualified electrician repair as necessary. For example, install additional circuits and/or electric outlets. From Garage door opener extension cord - InterNACHI Inspection Forum <http://www.nachi.org/forum/f19/garage-door-opener-extension-cord-22702/#ixzz3raDjcdLj>

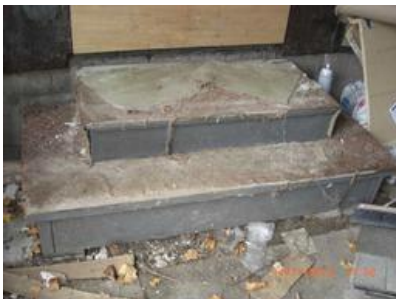
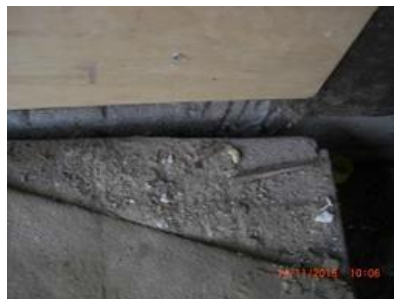
The stairs leading from the interior door are not attached to the house. While the stair unit is freestanding, if it became dislodged, it could pose risk of injury. Recommend contacting a general contractor for repairs as needed.

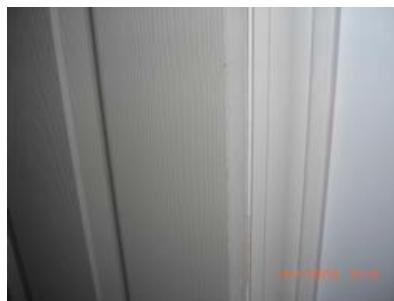
11/15/2015 Noted some doors did not close properly. Recommend contacting a general contractor for repairs as needed.

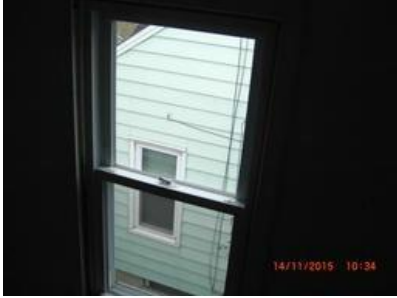
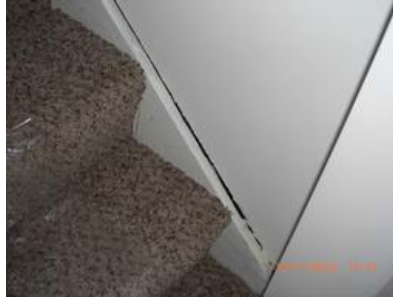
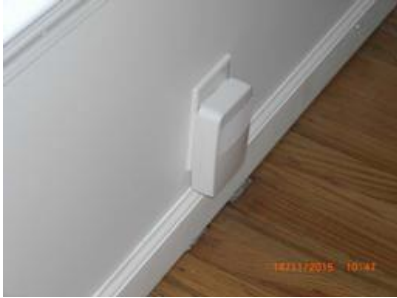
11/15/2015 Noted areas of missing trim exposing holes in drywall and or flooring. Recommend contacting a general contractor as needed for repairs.

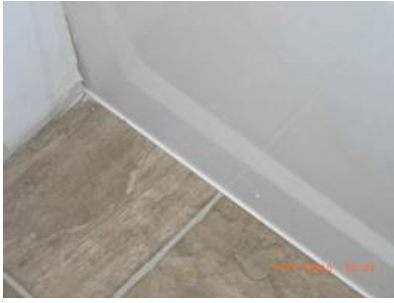
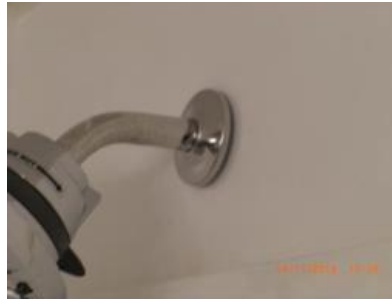
Noted missing caulk in bathtub area. This will allow water penetration to effect sub-flooring and may damage wood. Recommend contacting a general contractor as needed for repairs.

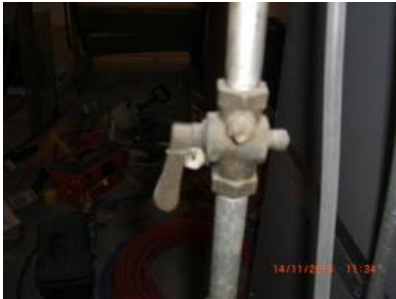
On the day of inspection a faint smell of natural gas was detected while standing in the basement. Further inspection revealed that the gas valve leading to the furnace is leaking. Also noted, the drip leg was missing. Recommend contacting an HVAC contractor for repairs as needed.

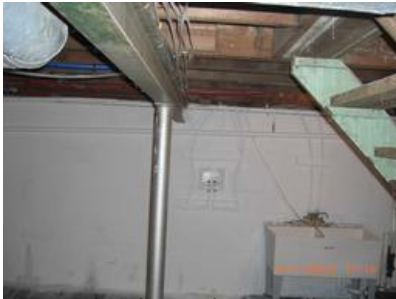
The pitch of the plumbing is a little steeper than I would expect to see. Normally the pitch is virtually flat allowing the liquids to carry the solids away. If the pitch is too steep, the solids will be left behind eventually clogging the line. Provided that there are no issues with the plumbing backing up (none noted the day of inspection), there is no defect. However, should there become an issue, I recommend having a plumber evaluate system and make repairs as needed.

Plumbing along wall

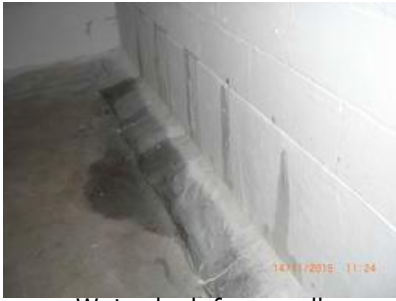
Along the garage-side wall, there was a noticeable amount of water accumulation. I could visually see water running down the walls. Also noted were a pattern of horizontal cracks on the same wall. Recommend having a mason evaluate and recommend remedy.

Water leak from wall

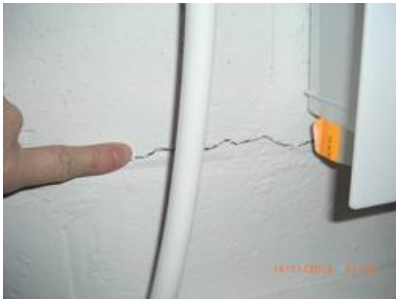
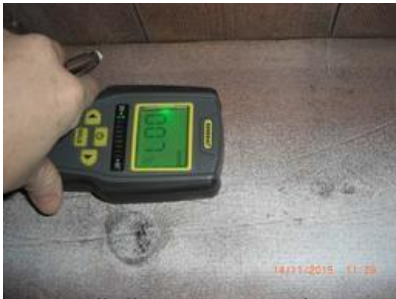
Horizontal crack

Sill plate garage side
