Welcome and thank you for choosing CNY Preferred Home Inspections.

Report Summary

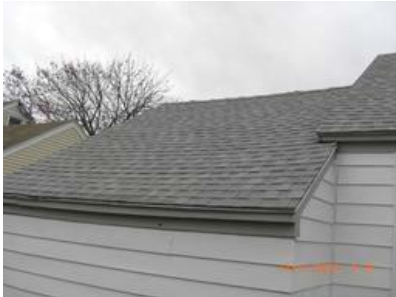
11/15/2015 Noted some sagging in the decking. (see Attic section)

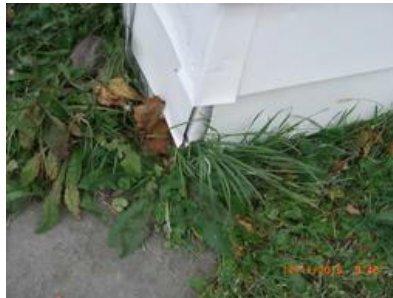
11/15/2015 Noted missing siding and gaps on outside corners (garage). Cosmetic damage noted throughout and the siding has come loose around the A/C unit disconnect. Recommend contacting a siding contractor for repairs as needed.

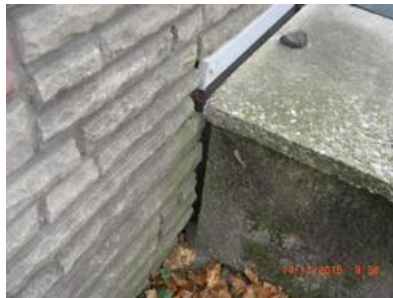
There has been some movement between the house and front porch slab. This is not uncommon for a house this age. Monitor this area for further movement possibly becoming a safety hazard. Contact a mason for repairs as needed.

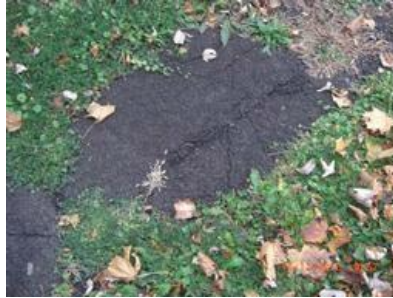
The main walkway to the front porch is covered with overgrowth and shows signs of deterioration. This is a trip hazard. Recommend contacting a mason for repairs as needed.

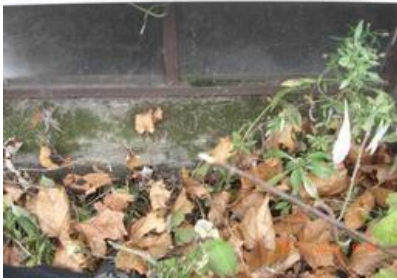
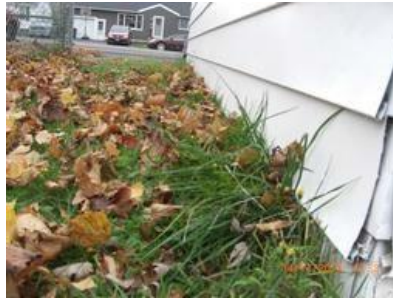
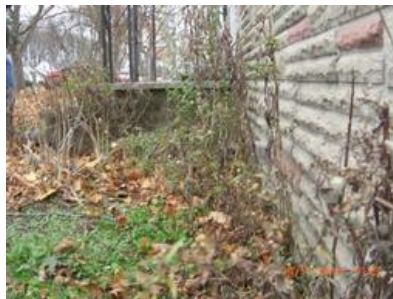
There is vegetation in contact with siding/foundation. Recommend pruning or removing vegetation so there's at least a one foot gap between vegetation and siding. This will help prevent water from pooling against the foundation.

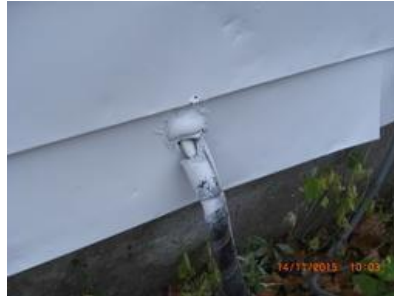
11/15/2015 Insulation did not extend the full length of the coolant line. Recommend contacting and HVAC contractor for repairs as needed.

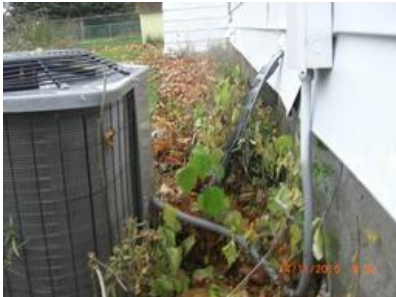
11/15/2015 Recommend removing debris from around the unit. It appears that some vegetation has grown inside the grill of the unit and should be removed.

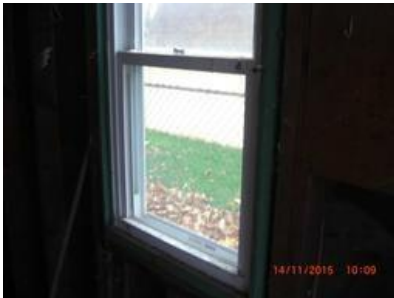
11/15/2015 The window in the garage did not open the day of the inspection. Recommend contacting a general contractor for repairs as needed.

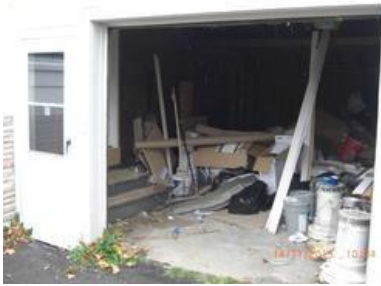
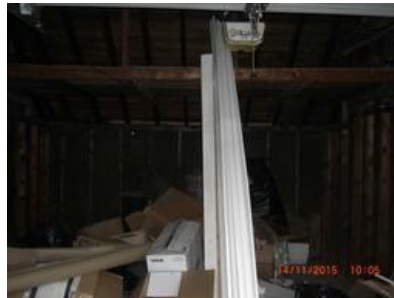
11/15/2015 Due to stored items, the garage could not be fully inspected. Once items are removed, I can come back and inspect.

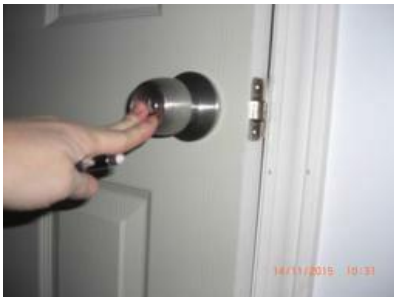
11/15/2015 Noted some doors did not close properly. Recommend contacting a general contractor for repairs as needed.

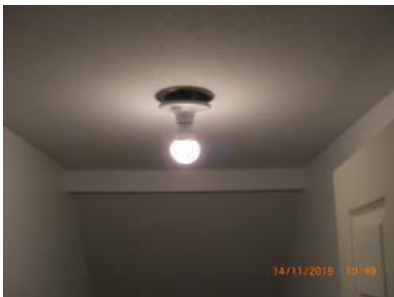
11/15/2015 Light fixture needs to be secured to the ceiling. Recommend contacting a general contractor as needed for repairs.

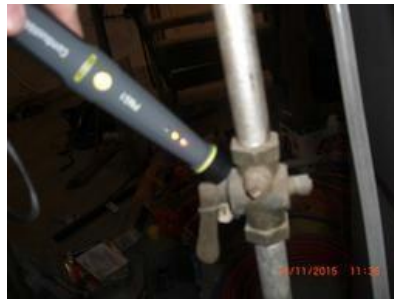
On the day of inspection a faint smell of natural gas was detected while standing in the basement. Further inspection revealed that the gas valve leading to the furnace is leaking. Also noted, the drip leg was missing. Recommend contacting an HVAC contractor for repairs as needed.

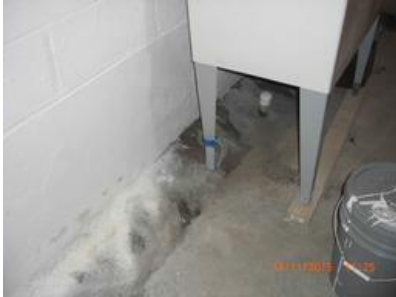
Saturation

Along the garage-side wall, there was a noticeable amount of water accumulation. I could visually see water running down the walls. Also noted were a pattern of horizontal cracks on the same wall. Recommend having a mason evaluate and recommend remedy.
